Rocky Flats Environmental Technology Site

Reconnaissance Level Characterization Package for the Building 111 Cluster

September 2000

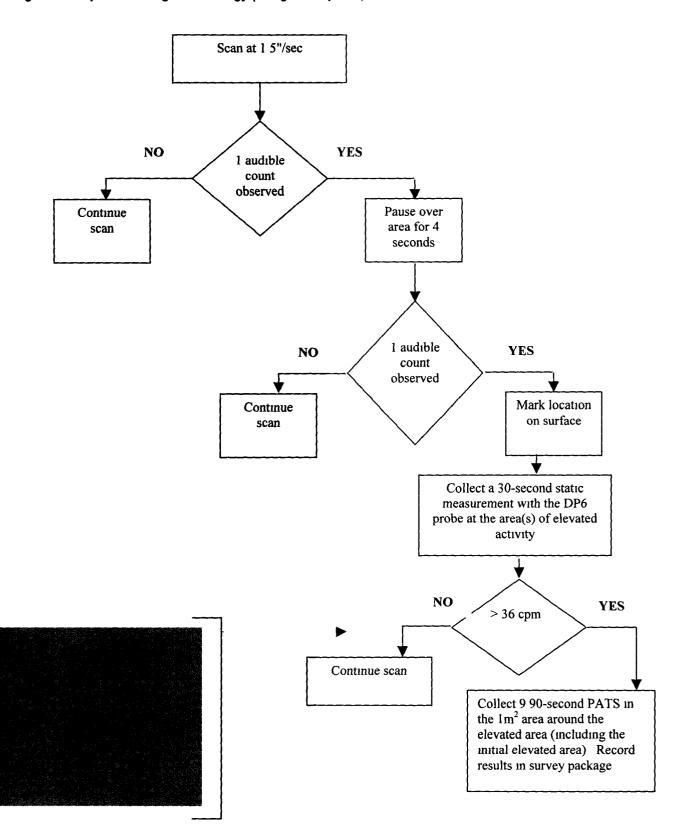
Figure 3.1 Alpha Scanning Methodology (using a DP6 probe)

Surface scan coverage for each survey unit will be a minimum of 10 percent (10 %), as listed in Appendix A, Table A-1 of the PDSP. Surface scanning for alpha activity will be biased towards areas of suspected contamination such as carpet surfaces, flooring, comer areas, lower walls, and window ledges. If extensive contamination is being found on lower areas of the survey unit, scans should be performed on the upper surfaces of the survey unit. Due to its tar/gravel surface construction, the roof of the B111 structure does not lend itself towards radiological scanning. For this survey unit, scanning will be biased towards areas that are more easily scanned, such as ventilation ducting, HVAC system component extenors, and other "non-gravel" areas. Survey unit maps of the roof will denote these areas, and the survey unit package for the roof will instruct the survey technicians to focus attention on these survey-able areas. Figure 3.1 shows the methodology to be used for performing alpha scan surveys.

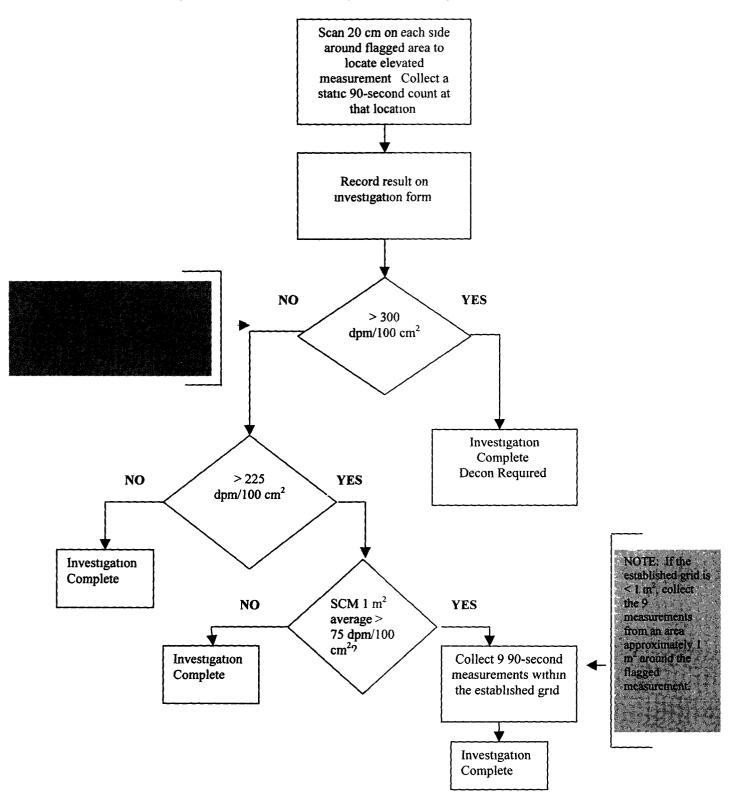
Figure 3 2 Investigation Method for Elevated Alpha Scan Reading (DP6 Probe)

If an area of elevated activity is identified during the scan of a survey unit, an investigation will be performed to confirm the presence of elevated activity. If elevated activity is confirmed, the location of interest shall be marked, and surface activity measurements for total and removable activity shall be performed at that location. Figure 3.2 shows the investigation methodology to be used for performing an investigation.

Note that investigation locations will be in addition to the randomly prescribed number of measurements for that survey unit. This additional measurement location will not be included in the survey unit statistical test. Rather, it will be compared directly to the applicable DCGL_{EMC} (for 100 cm²) and the DCGL_W (for average over m²)

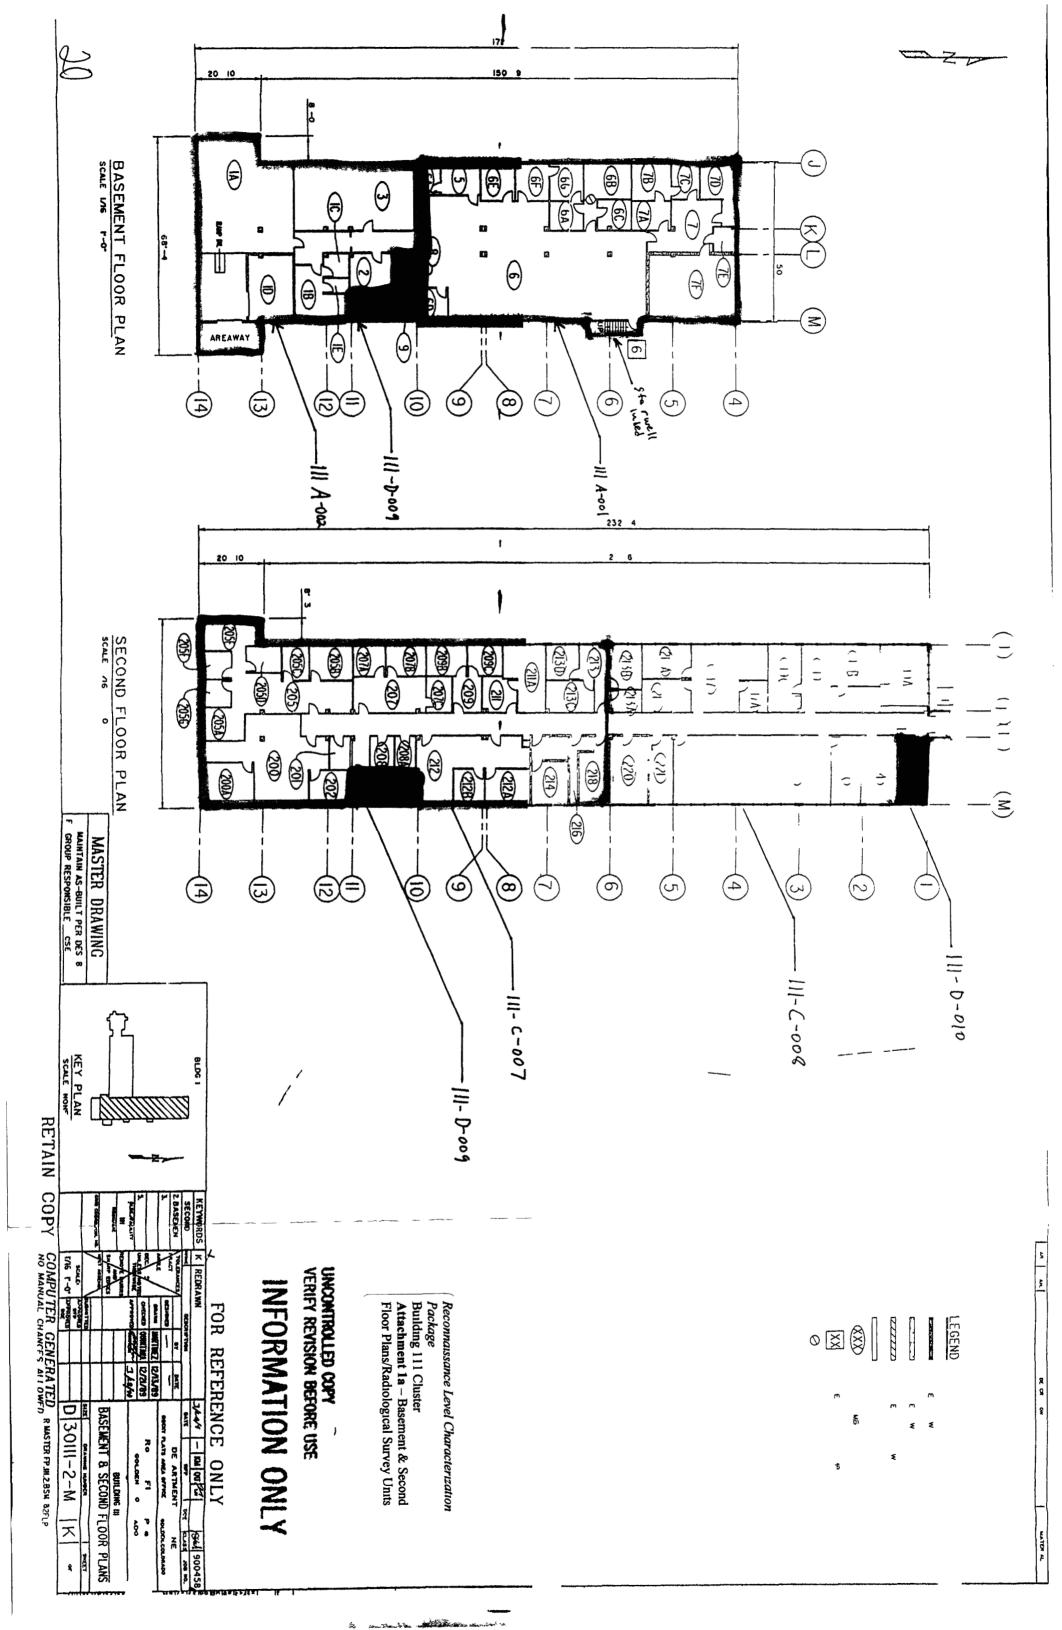
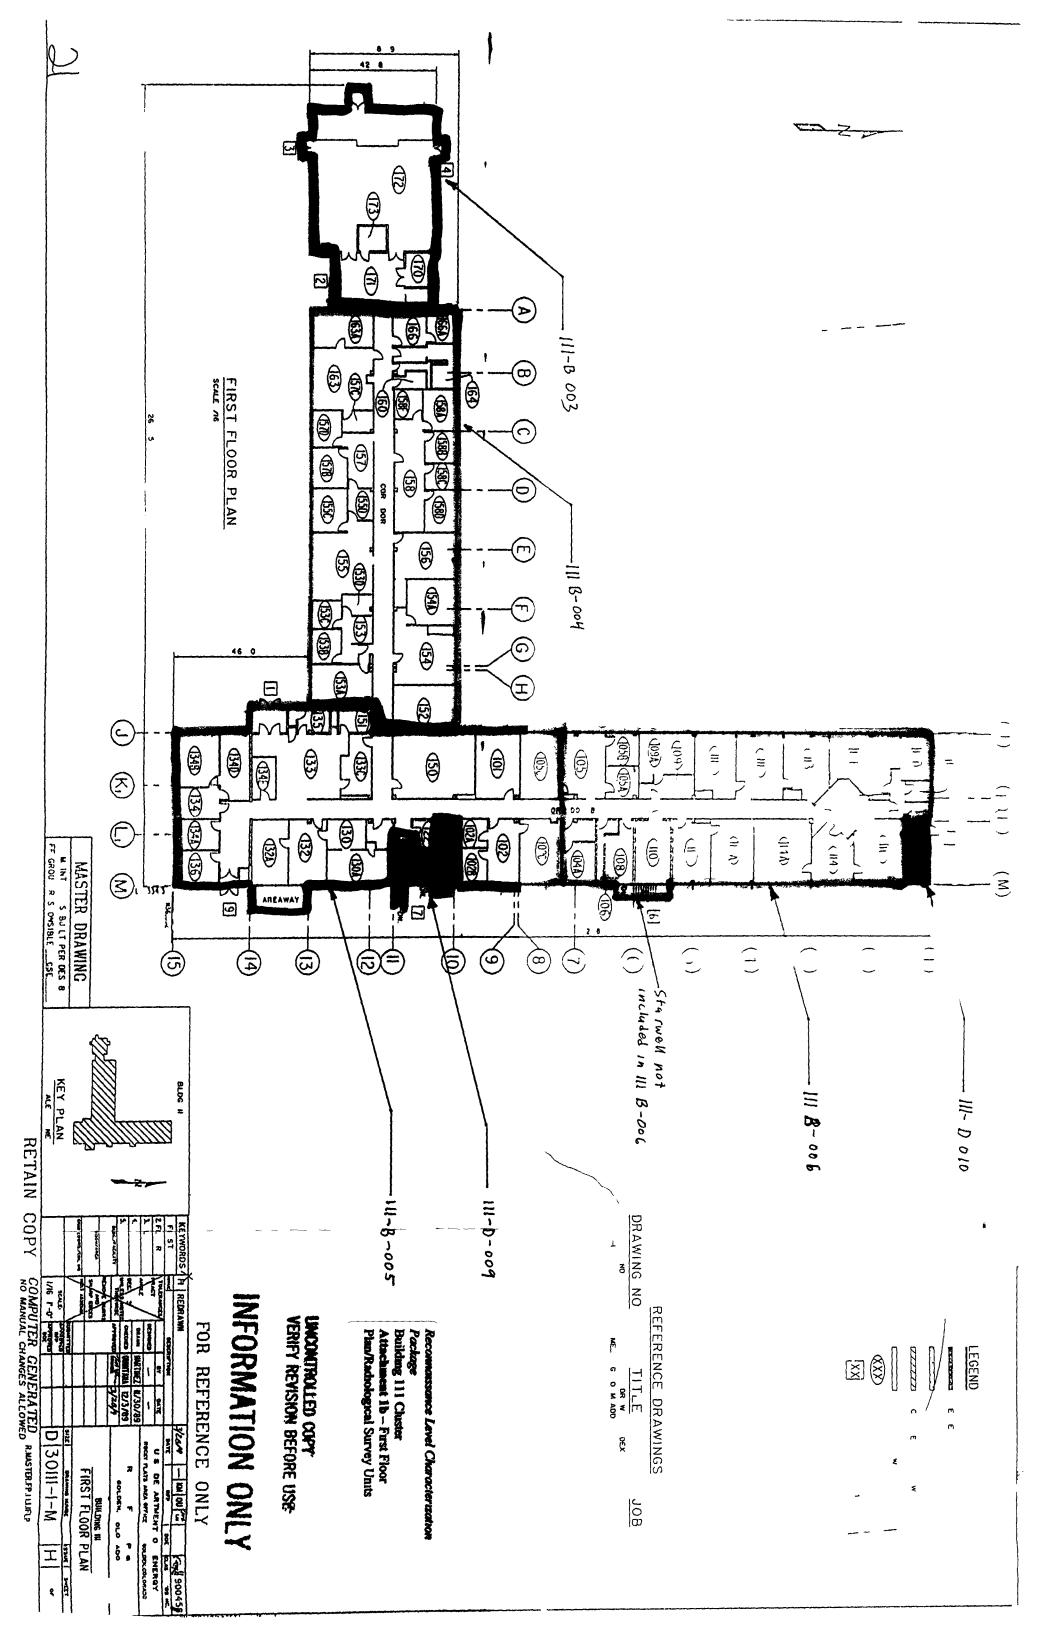
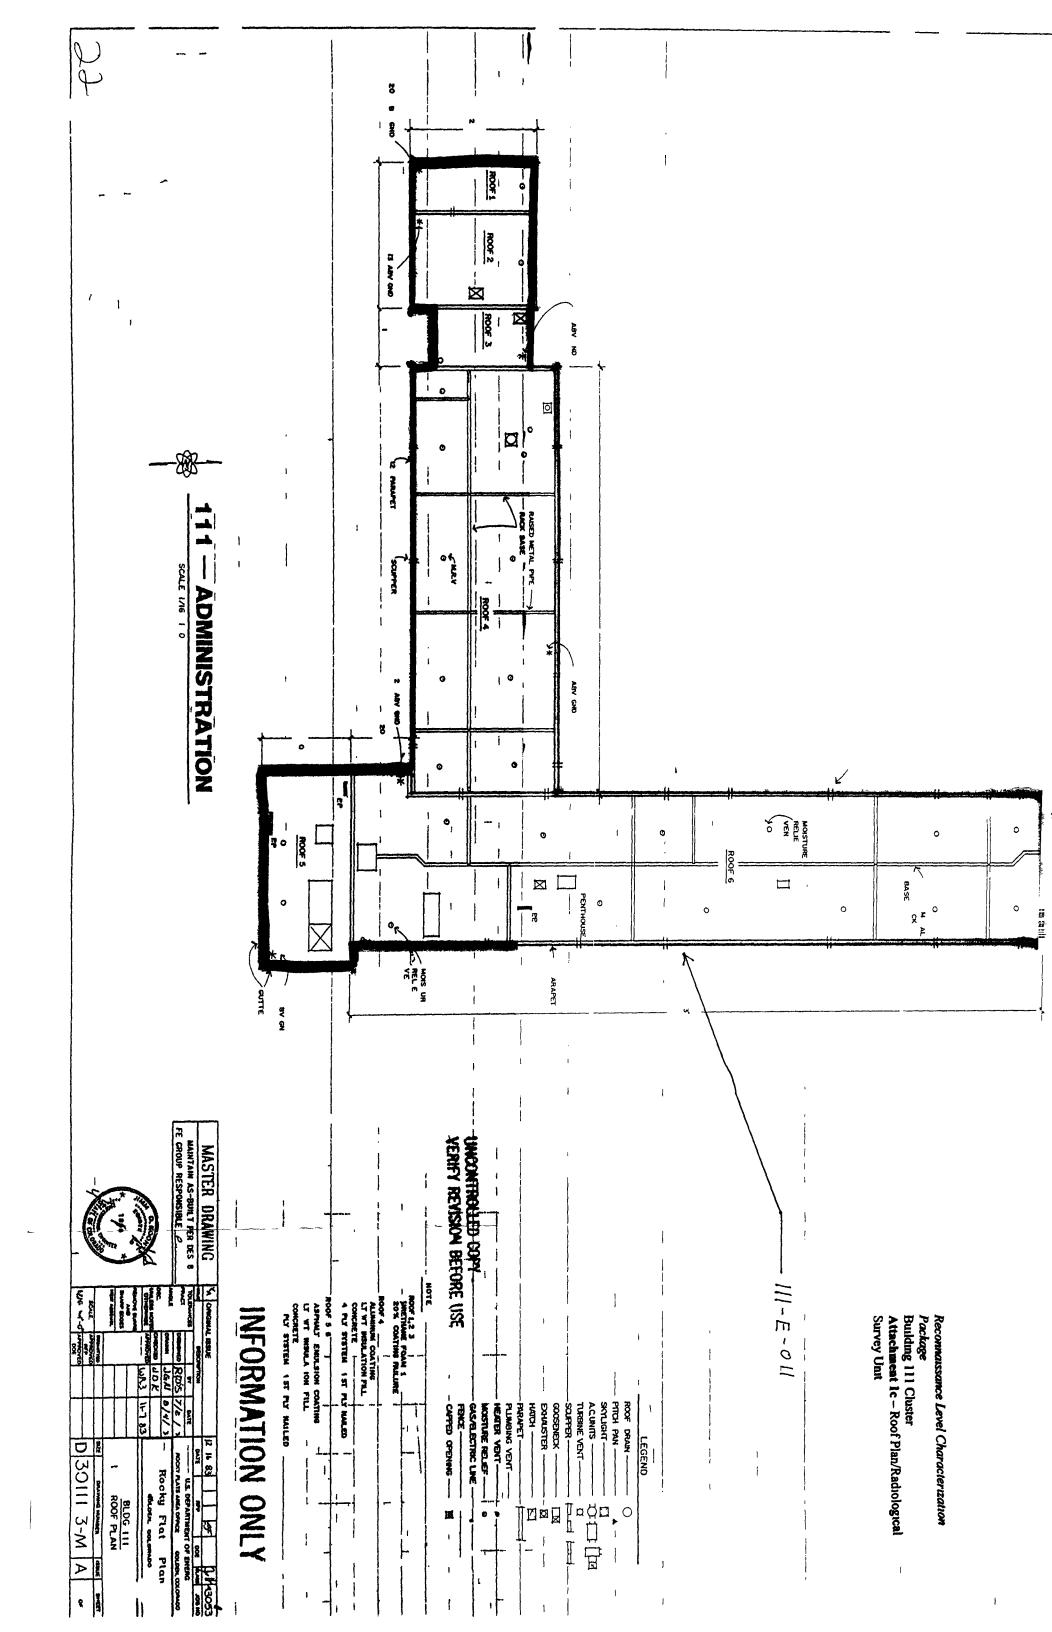
These survey areas are broken down further into 14 survey units based primarily on similar characteristics and contamination potentials. Survey unit designations are shown in the attached floor-plan maps (Attachments 1a, 1b & 1c) and are described in Table 3-1
